## Position of the rubber grip on golf clubs

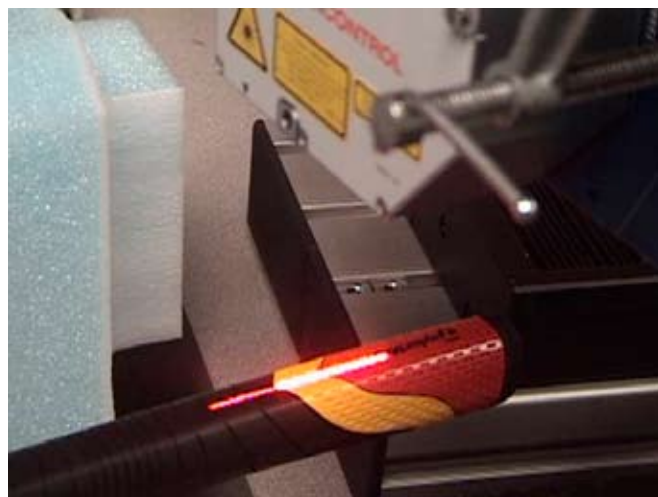
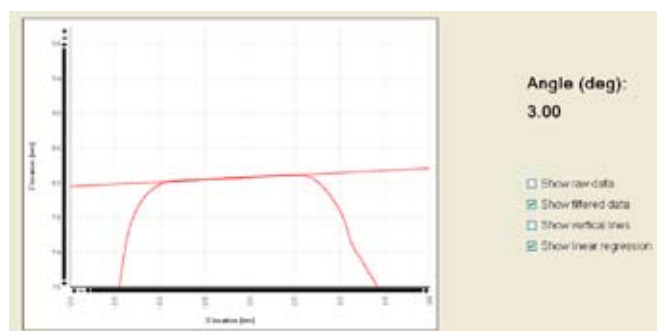
Cross-section of a golf club

scanCONTROL 2800 is used in production for this type of inspection. The rubber grip is moved at right angles to the laser line. The condition of the rubber can be determined from the measured profiles. scanCONTROL functions completely without making contact with the target surface. Therefore, the rubber is not damaged during measurements, which can occur if contact measurement methods are used. A special housing protects the optical system against dust and other airborne contaminants. The scanner is connected to a PC via a FireWire interface. A customer-specific software application on the PC enables evaluation of results.
